# Crack detection on forged parts

## Induction thermography

### Test part

The test part is a forged steel shaft fork.

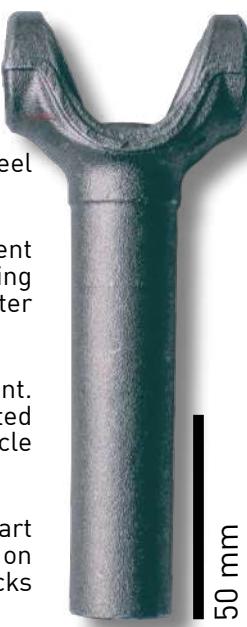
The test area is the fork part where cracks typically appear on the sides of the prongs. Cracks have no particular direction.

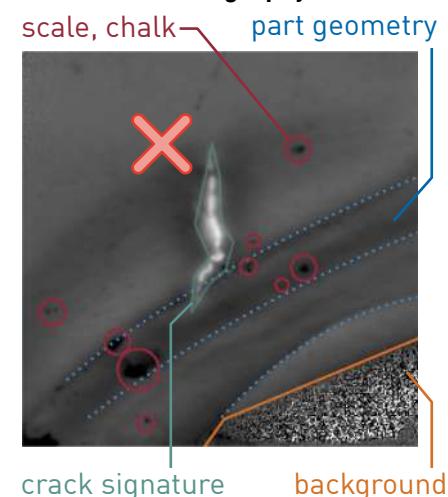
### Induction thermography

Cracks can be detected with induction thermography. An exemplary recording is shown below.

Crack signature patterns occur with a high intensity. Recordings are reproducible. Disruptive pattern may also occur. They originate from scale, chalk markings and the edges on the part geometry. None of the disruptive patterns are significant as compared to the crack pattern.

In comparison to magnetic particle testing, induction thermography performs significantly better. Crack patterns are much more pronounced in contrast in relation to disruptive patterns and noise. An automated image processing algorithm can easily be customised to find such patterns.
