# Crack detection on forged parts

## Induction thermography

### Test part

The test part is a forged steel shaft fork.

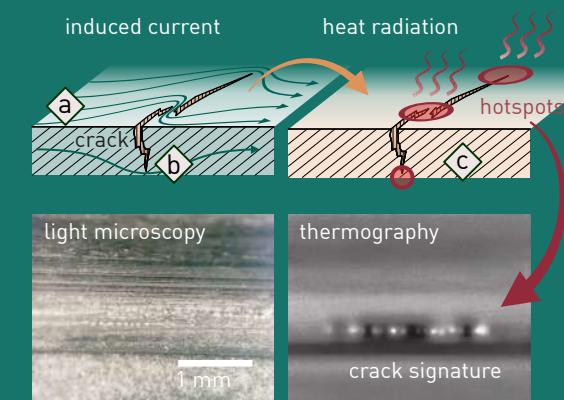
Induction thermography uses an induction coil (1) to produce currents in a conductive test part (2). The thermal response is monitored with an infrared camera (3).

Cracks constitute an obstacle for induced currents (a). This results in strong local variations in current density where the currents circumvent the crack (b). Areas of high current density become hotspots (c), low density area become heat sinks. The heat radiation is picked up by the camera and cracks manifest as beaded patterns on an induction thermography recording.
